# Renovating An Old Building For Cultural Use: A Study In Unreinforced Masonry

RICHARD EBELTOFT  
University of Arizona  
USA

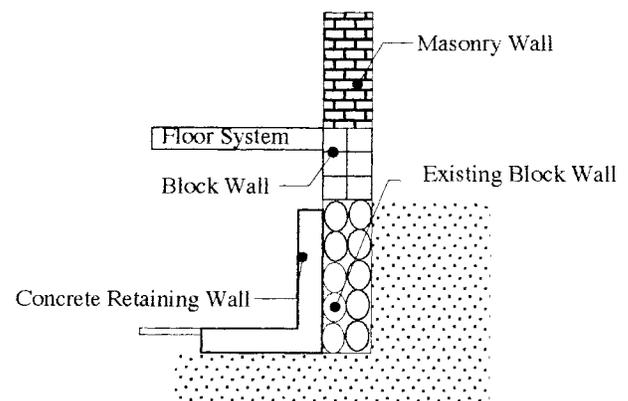
**Schematic Wall Section**  
**Figure 1**

The foundations and basement walls were distressed. The basement walls were a rock construction. Below grade the rocks were uncut natural shapes set together with a lime mortar. Above grade they were cut stone set with mortar up

to the floor level. The existing roof drains were ejecting water next to the exterior of the basement walls. Over the years during the rainy seasons this area was periodically subject to partial saturation. Due to the repeated moisture penetration, the lime mortar deteriorated to the point the basement retaining walls were no longer a viable. Prior to this investigation, one portion of the North wall partially collapsed and was replaced with a reinforced masonry wall.

Several options were discussed for stabilizing the wall. For example various types of tie backs were considered. However, due to the large size of the rocks in the wall, the tie backs would have require drilling through the rocks and possibly removing some of the outside soil from the wall area. This option exposed the wall to excessive vibrations that, because of the poor condition of the mortar could destabilize the wall and possibly cause its' collapse. The basement wall was subject to a very large axial load because of the high masonry walls above. Consulting with the geotechnical engineer it was concluded that the vertical wall capacity would be adequate if we could contain the existing mortar in the wall and prevent further moisture penetration. It was necessary however to confine the mortar in the wall and to improve the lateral capacity.

It was decided that the most economical solution was the use of a cantilevered retaining wall, adjacent to the inside face of the basement wall, to provide the lateral restraint. This wall would extend up as high as the soil on the exterior wall. [See Figure 1] To accomplish this the foundations were installed by removing a strip of the floor slab around the perimeter by saw cutting. Then foundations were then carefully excavated next to the existing wall foundations. The foundation of the cantilever retaining were placed next to the existing foundations and were brought flush with the floor so that it served as a new perimeter strip of floor slab in the basement. A reinforced concrete cantilevered retaining wall from was constructed immediately in front of the rock basement wall. The wall was used as the back form and the concrete was placed in the cavity between the form and the wall. This provided restraint for the existing mortar, filled in any gapes in the rock wall and

provided additional lateral restraint for the basement wall soil loads. This option examined was the most economical solution and it stabilized the wall very well. The basement served only as a storage area and maintaining the historic character was not a requirement by the owner and architect.

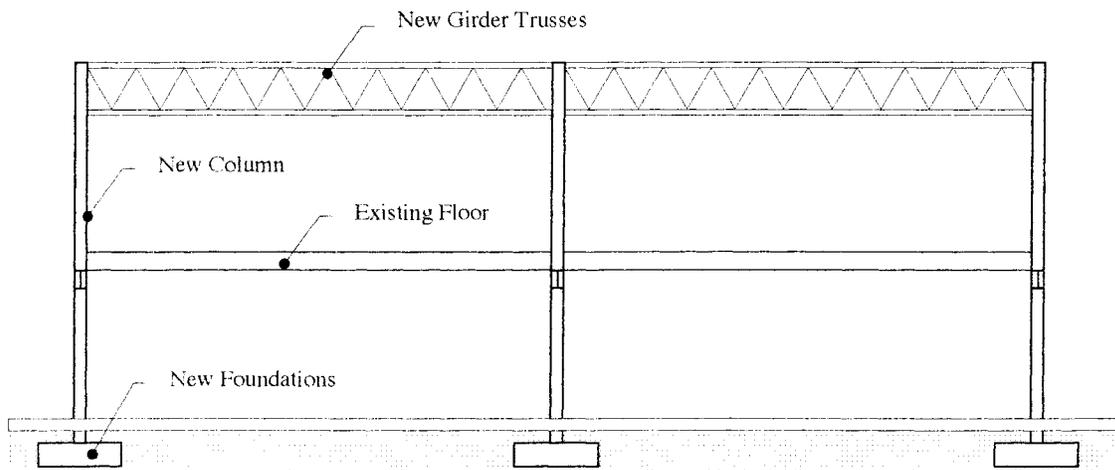
**Schematic Frame Elevation**  
**Figure 2**

The next issue was the additional gravity loads on the structure due to the addition of stage equipment, catwalks, lighting and other elements required for the conversion to a theater building. After a preliminary investigation of the new load requirements, it was decided that an independent load structure would be the best strategy to accommodate them. Several structural configurations were investigated, from a three dimensional truss to a simple frame. The budget restraints were quite sever however so the simplest and most cost effective method was chosen, which was a simple steel frame. This supported a future catwalk and all the lighting and other equipment required.

The floor structure over the basement consisted of wood joist and wood beams. The wood beams were over stressed by the new loads and needed to be reinforced. The steel frame, again was used to provide this support. The steel frame columns were installed adjacent to the existing floor columns. This allowed the installation of steel cross beams at the floor level under the existing wood beams. This provided adequate capacity for the new floor loads. Additional small perimeter columns were installed to support the floor joist outside the center column area.

The some of the trusses were failing in the center cruciform area of roof structure. Because of structure of the truss and the limited access in the roof attic, the repair of the failed portion of the trusses would have been a very time consuming and expensive process. As an alternative it was decided to provide the roof support in the locations of the failed truss by using the steel frame below. Columns were installed from the steel frame up to the trusses at locations where distress had occurred. This resulted in a very economical repair to the trusses.

In order to construct the frame large square steel tube columns were installed from the basement floor through the main floor and up to the roof level of the structure. (See Figure 2). Prefabricated girder trusses were installed along the long building axis column lines. Prefabricated cross trusses spanned the short direction. These trusses which were connected at the columns were also designed to provided partial lateral support in both directions. The frame was designed to carry these lateral forces as well as gravity forces by developing moment resisting connections within the system. This was not required by code however since the structure was there for gravity loads and it was very inexpensive to add the lateral capability. The result was a light airy structure that was unobtrusive on which equipment could be mounted and dismantled very easily and effectively.

as a control and lighting booth. The floor structure of the mezzanine was mounted to the columns of the frame. It was easy to connect to the columns, and made for a very economical floor system.

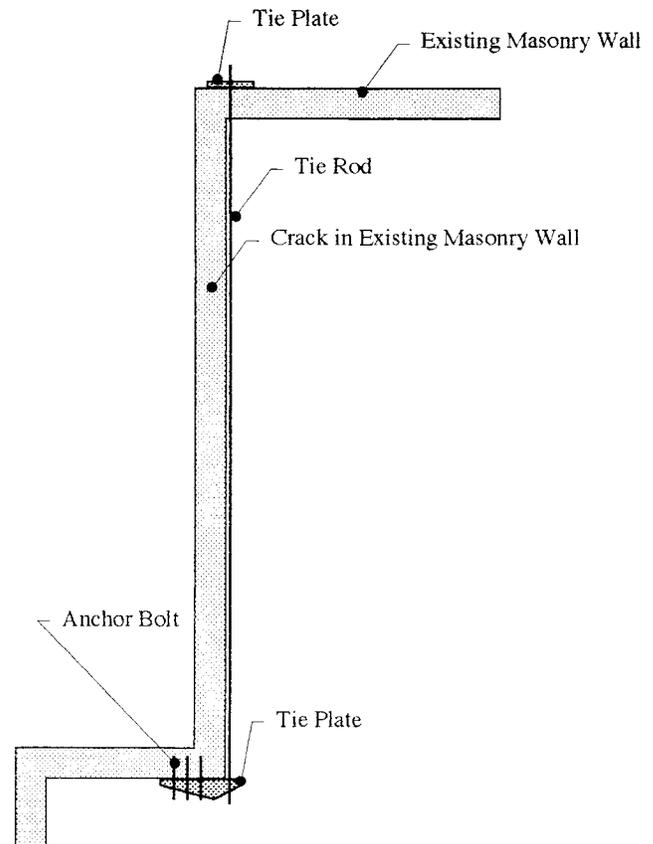
**Wall Preload Rod Plan**  
**Figure 3**

Some time before the investigation, the basement floor had been flooded by water from a broken main. This resulted in some foundation settlement on the South-West corner of the building, which caused some cracking along the window lines of the upper structure. The Geotechnical Engineer indicated that the settlement would stop if there was no further exposure to water. The repair resorted to using a surface prestressing rod to stabilize and hold the wall in place. Since there was steel super-structure used on the inside for gravity support, A steel prestressing rod on the surface was entirely consistent with the design. The connection was a corner load plate designed with tension rods that connected from the corner through one of the existing walls that served as a tie back. See how this functioned in the enclosed diagram in figure 3. This served to stabilize the wall from any further cracking. Concrete walks were installed in locations where potential moisture problems might occurred to prevent any further moisture from intruding from outside.

Besides carrying the new gravity load and some of the lateral forces, the frame served several other functions. It provided a location where connections could be made tie down the roof structure. The roof was a light weight metal tile roof that needed to be tied down for uplift wind loads. In addition the unreinforced masonry walls at the roof level were tied to the frame to provide redundancy for lateral loads. The walls were connected by means of through bolts and plates from the frame to wall, a standard way of developing connections for unreinforced masonry structures. The connector was also tied to the roof diaphragm so there was a double action of an existing roof diaphragm that was partially effective and the frame both resisting the loads from the walls. It was an efficient use of the moment frame and made for a more stable structure with the walls and roof tied to the steel frame.
