ecoMOD3 — The SEAM House: Preservation as Social and Environmental Justice

JOHN QUALE

University of Virginia

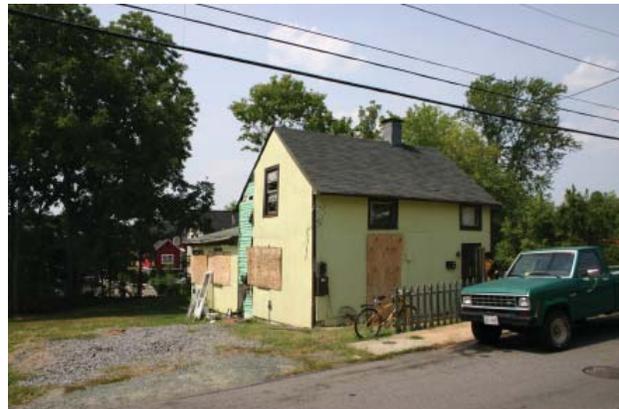
Figure 1. ecoMOD3 historic house before

bors were surprised to learn it had received a historic designation. The neighbors felt the home was an eyesore, and should be torn down to make way for more affordable housing. The linkage between preservation and sustainability was part of the ecoMOD team's justification for helping to keep the structure, but it became pretty clear that the team would have to remove so much of the fabric of the building to stabilize it that the final result would essentially be a new building. A report from a local structural engineer validated this assessment. The foundation and much of the original framing would have to be replaced and / or supplemented.

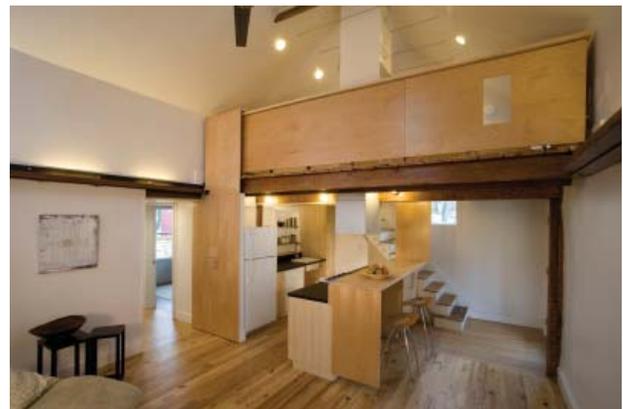
Figure 4. interior of ecoMOD3 accessory unit, showing 'SEAM' at right

The rear accessory unit has super-insulated wall and roof panel construction; low-impact materials;

a modular green roof system; a deck with trellis-shade device; a rain garden and courtyard. The landscape and green roof mitigates the storm water on the site. The team aims for a gold or platinum rating for the accessory unit within the LEED for Homes certification program, choosing not to certify the historic house because of the complexities of submitting an existing structure.

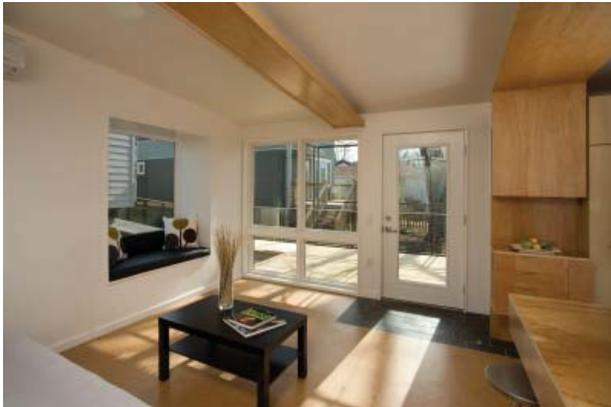
Figure 5. interior of ecoMOD3 historic house

Another challenge the team faced was with the re-installing the flooring. Much of it appeared to be in good condition, and some of it was not. The builder was concerned about the difficulty of re-installing the flooring, but the HP team was committed to saving as much of it as possible, and reusing it in the home. The students took the flooring to the ecoMOD fabrication facility and sorted it by size, vintage and condition. They trimmed the good pieces, and sent all the truly 'bad' pieces to a wood recycler, but were able to clean up the vast majority of the material. They didn't have quite enough of the newer (perhaps mid-20th century) oak flooring that was going into the bathroom, so the builder purchased some inexpensive new oak that matched it perfectly. When the floor was sanded and finished, the students felt vindicated because the floor looked terrific – almost too good because it was difficult to tell it was old wood.
