# Alternative Practices: A Case Study of African American Construction

JORI A. ERDMAN

Clemson University

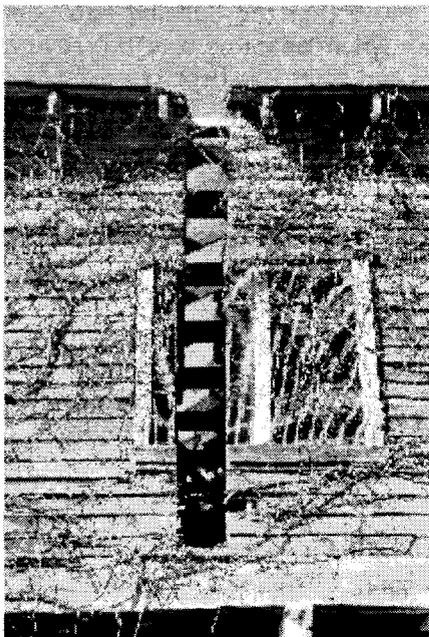
**Figure 4** Dissection cut through the building leaving structural members intact.

After a series of design workshops with professional engineers and construction experts, we developed a strategy we called disassembly. Our methodology appropriated the scientific analogy of dissection, making a series of cuts through the building to reveal the section of the building. The section not only allowed us to study the spatial condition of the structure, but also the way the building was put together. Another part of the methodology involved removing layers of the existing building fabric to reveal the aggregated nature of additions.

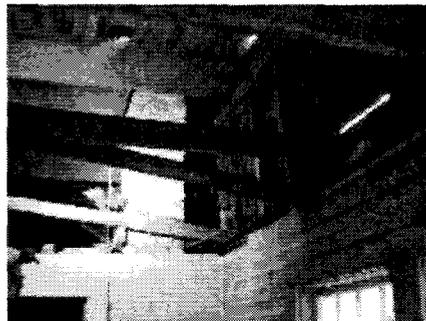
**Figure 5** Roof/ceiling joists and chimney, evidence of a previous one story structure.

Through the removal of layers within the interior of the structure we were able to begin to speculate about the buildings additions. After fully documenting the existing conditions, we began to strip away the layers of finishes in the most dense part of the structure, three rooms that had been the residence within the building. As we pulled off the layers of wallboard of a dropped ceiling, we discovered joists that had clearly been part of another structure or at least had been using in another type of building section. The ceiling joists were arrayed parallel to one another with an average spacing of 24". But on the top of the joists were bird's mouth notches located at the outside wall. The other end of the joists were cut at an angle which immediately indicated that they had been used previously as part

of a roof structure. The removal of the dropped ceiling revealed the interior of the wall's framework above the line of the ceiling. Within this space we could clearly see the original framework of the wall studs. Further evidence was revealed as disassembly continued at a chimney where we discovered roofing sealant at the first floor level and new brick construction above.

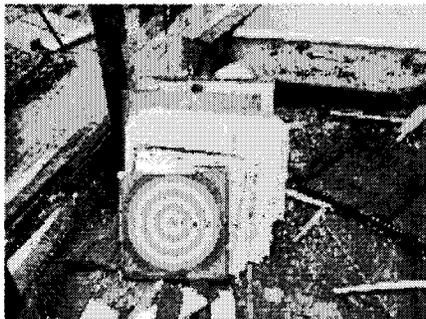
**Figure 6** Targets used as wallboard in bathroom.

Our stripping of interior finishes revealed many instances of the adhoc nature of the construction. In the bathroom located on the main floor we discovered that the wall covering was created from squares of particle board printed with targets and painted over. This moment of whimsy in an otherwise sober and relatively barren building provided us with additional insight into the mind of the builder and the community. The appropriation of the targets for use as wallboard was only located in the bathroom and no where else in the building. While there may have been some functional or practical reason for their use, we preferred to credit Mr. Keese with a sense of irony and sly wit.

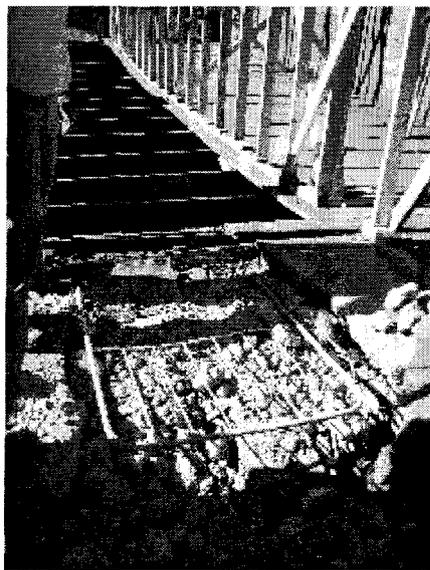
**Figure 8** Baby crib used as concrete reinforcing.

The targets found in the bathroom were just one example of Ben Keese's use of unorthodox materials in the construction of his building. He was not above using the objects of his antiques trade for building materials. While the targets in the bathroom were one humorous example, in other places we found pieces of furniture used as structure. A metal Orange Crush sign was reformed to become the door to the roof hatch in the attic space. Unearthed footings in the crawl space were revealed to be a broken marble vanity or table top. We were able to piece the entire top together so it remains uncertain if Mr. Keese actually broke the top himself to use under the piers, or if the top was already broken and therefore fodder for construction. Upon breaking up a section of the concrete porch, we discovered that Mr. Keese had used an old metal baby crib as reinforcing in the slab. The pieces were turned perpendicular to one another to form a close approximation to contemporary heave gauge reinforcing mesh. The construction indicated an understanding of the principle of concrete construction; it was simply in the execution that we found the adhoc.

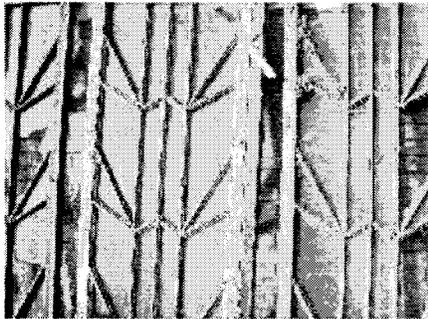
**Figure 9** Keese Barn sunroom window with unique mullion pattern.

at the time of our disassembly however we found the original pieces of the room within the building itself. The enclosure of the sunroom was evident in many of the pictures we had of the Barn so we were certain of its location and disposition. In addition, many narrative accounts from community members showed that the sunroom was one of the most memorable features of the structure itself. Mr. Keese had constructed the room with windows or doors (we assume the majority of them were windows as we could find no indication of door hardware) with a very usual mullion pattern that could best be described as an abstracted tree form. From the community we also learned that many members recalled the day the windows arrived (as they would have been young children at the time, this would have been a remarkable day for them).

As I described previously, Mr. Keese had learned the antiquing trade in Philadelphia and made trips North throughout his life collect goods for his business. Apparently he purchased the windows on one of these trips and had them shipped to Pendleton on the train. As was typical for this time, he had to recruit men to help him pick them up from the station so they hitched up a team of mules and picked them up. Thus the impact on the children of the community as this created a festive, parade-like quality to the event. Upon telling this story to one of our consultants from Philadelphia, we learned more about Ben Keese and the community. Our consultant informed us that many African American churches in Philadelphia had attempted to education young men from the South by bringing them North to learn business skills. We have assumed that this was the case with Ben Keese. Unfortunately we were not able to place the fabricator of the windows although we consulted with several dealers and
