### Twenty years of Double Skin Systems: from Occidental Chemical to Telus

*Occidental Chemical Center (Hooker Building), Niagara Falls, NY, USA, Cannon Design Inc.*

*The Telus Headquarters (William Farrell Building), Vancouver, British Columbia by Peter Busby and Associates*

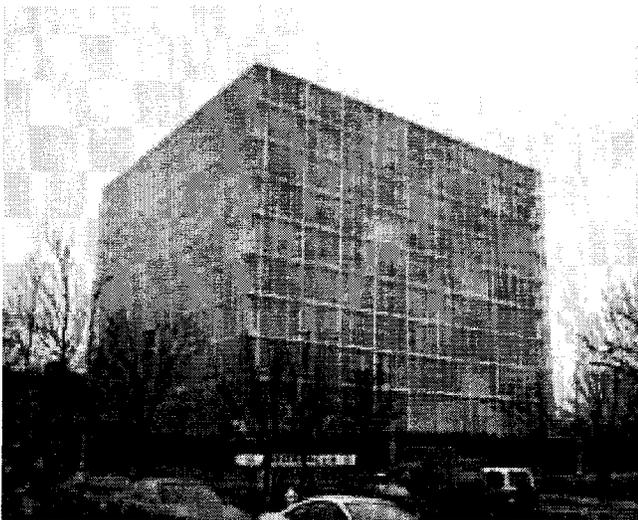
Fig. 1. Exterior view from U.S. Customs

The outer skin was double-glazed. The outer pane was a blue-green glass and the inner pane was clear. For the time the choice of a simple iron oxide glass was the result of a selection to use glass chemistry that would maximize light penetration while simultaneously limiting solar gain. Mullions are at 1.5 m on center and transoms at 1.8 m. The inner skin is floor to ceiling single glazing.

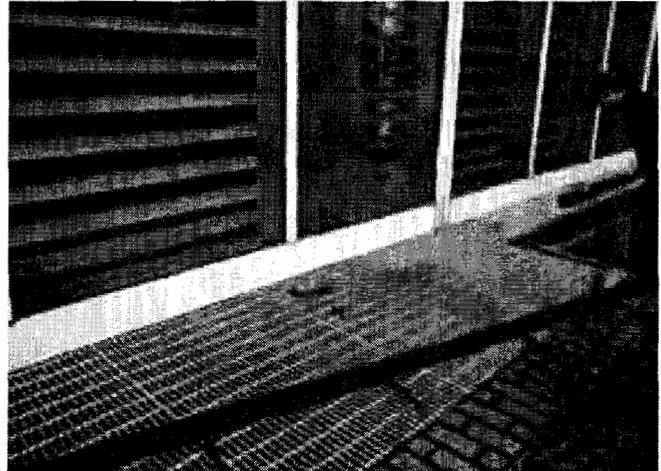
Fig. 4. View of air intake grille at base of building. Note clouding on center glazed unit.

Approaching the building, it looks to be in pristine condition. Closer examination would reveal otherwise. Many of the original design intentions and systems of the buffer façade system are no longer functioning – either in whole or in part. A significant percentage of the glazing appeared to be clouded. We initially assumed these panels to be the result of a broken seal on a double glazed unit. This proved incorrect. The coating on the interior surface of the exterior glazed skin was disintegrating or delaminating. Proper maintenance

and cleaning of the louvers has not taken place. The air space and associated louvers were "filthy". This could be credited to lack of cleaning, or, site conditions as a result of the recent excavation. The grilles at the base of the cavity are presently closed off with large plywood planks. Although the cavity was originally outfitted with motorized dampers, the presence of the plywood would indicate that these are no longer functioning.

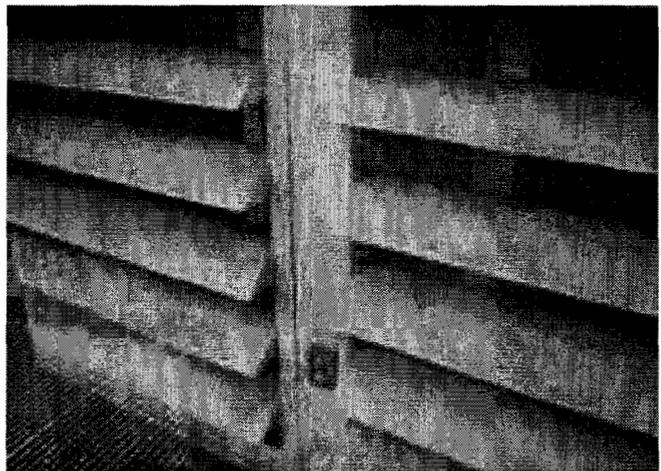
Fig. 5. It can be seen that the louvers are fixed in a horizontal position, painted white and are very dirty.

According to security and maintenance, the brightly finished louvers were painted white early on in the life of the building due to the glare issue. This would have had an appreciable change on the diffusion of sunlight into the building. The computer controls for the louvers ceased to function approximately 4 years ago. They have not been repaired. They are now fixed in a horizontal position – inferring that they will provide only partial shading (particularly on the east and west elevations). It was apparent that tenants had decided to supplement the building shading with their own "personally controllable" louvers in the form of vertical blinds. The interview revealed that the tenants are NOT comfortable, complaining that the building is either too hot or too cold. If the louvers and dampers are not functioning the heat accumulated in the summer months will build up rather than be expelled. Proper shading will also not take place. During the winter, although heat may be generated in the air space, the louvers that were intended to rotate into a closed, insulating position, will fail to provide heat retention at night.

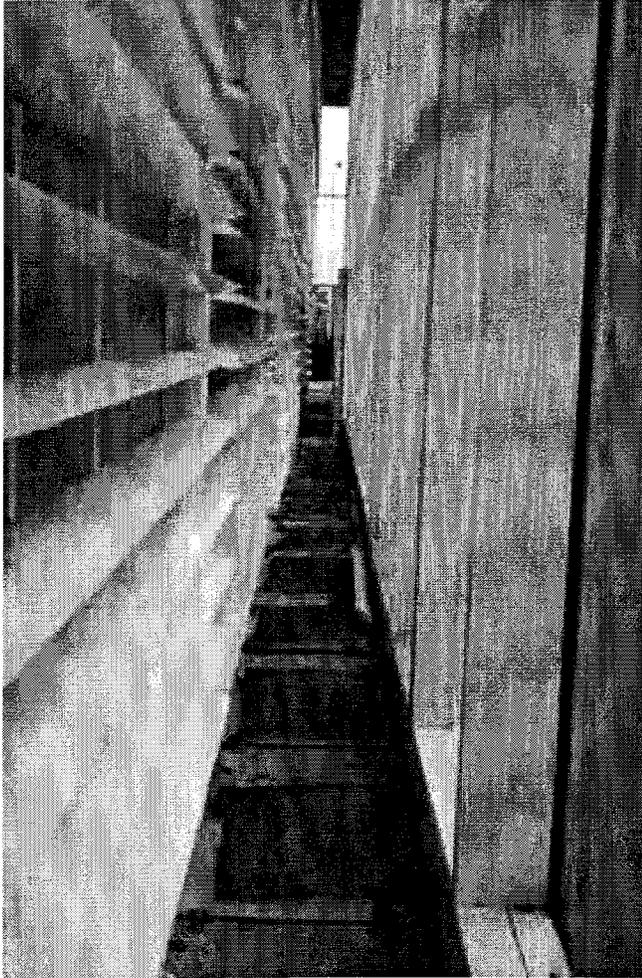
*Fig. 6. A view inside the cavity showing its clear width to allow for maintenance; the plywood sheets that close off the grille at the base preventing air intake.*

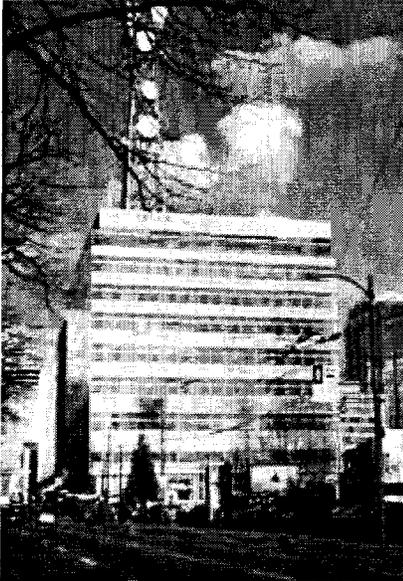
Fig. 7. View looking north

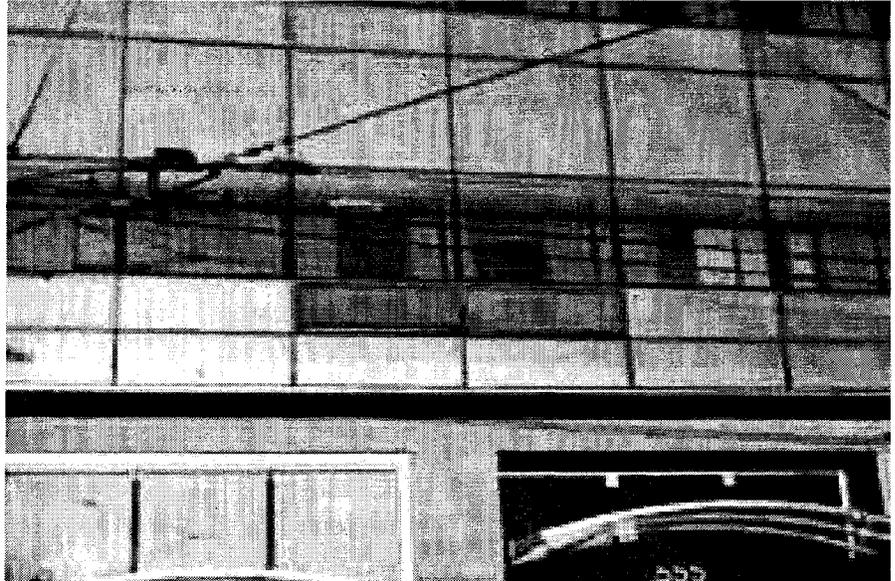
Fig. 8. Here we can see the differentiated glazing: clear versus fritted glass, and two of the operable windows in an open position.

Whereas the glass on Occidental Chemical is uniform over the entire building envelope, the Telus Building has used differentiated glazing: clear vision glass in a band on the exterior skin that aligns with the interior windows, and fritted glass in the "spandrel" sections to cut out unnecessary heat transfer.

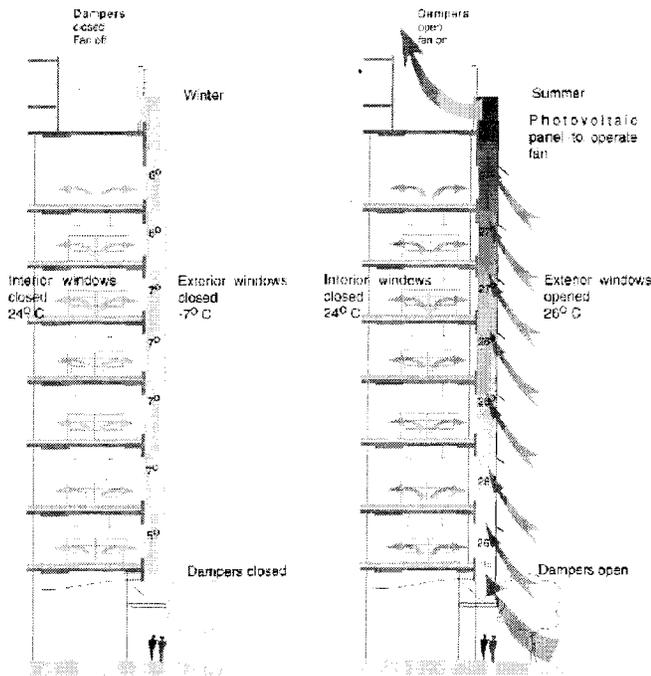
Fig. 9. Winter Wall Section  
Dampers closed

Fig. 10. Summer Wall Section  
Dampers open

*"The double skin acts as a ventilation chimney in warm weather and as an insulation jacket in cool periods. In winter months louvers at the top of the double skin remain closed, trapping a layer of air, allowing the building mass to retain available solar energy, which is then reradiated into the building. The exposed concrete structure acts as a heat sink, helping to reduce temperature fluctuations. In warm weather, with the louvers open, heat building within the double façade causes convection air movement. Assisted by fans, warm air is drawn up and out of the top of the air space, creating negative pressure within the interior, which in turn draws warm air away from the occupied areas."* John McMinn, 2001

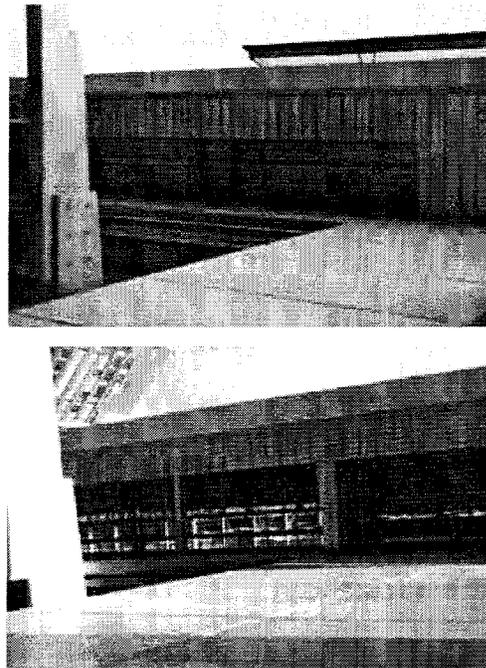
Fig. 11. View from below: base grille in closed position  
Fig. 12. View from below: base grille in open position

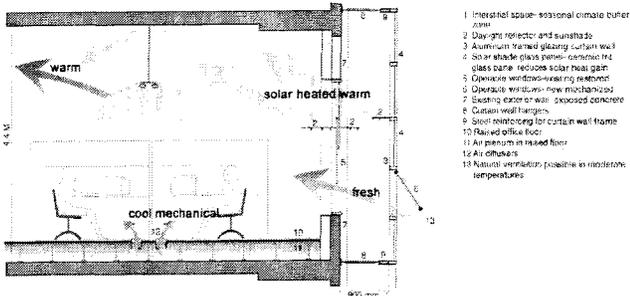
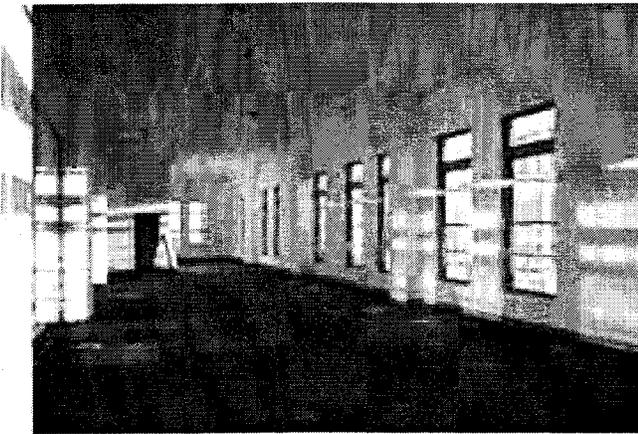
Fig. 13. View of interior, façade faces south west, 4 p.m., November

Fig. 13 was taken prior to occupation. The white painted interior was very brightly lit. The low sun angle provided penetration to the back corners of the office space. Much shading is provided by the

existing concrete wall. In fact, were it not for the ratio of wall to window area, the glare in the space would make the working condition impossible.

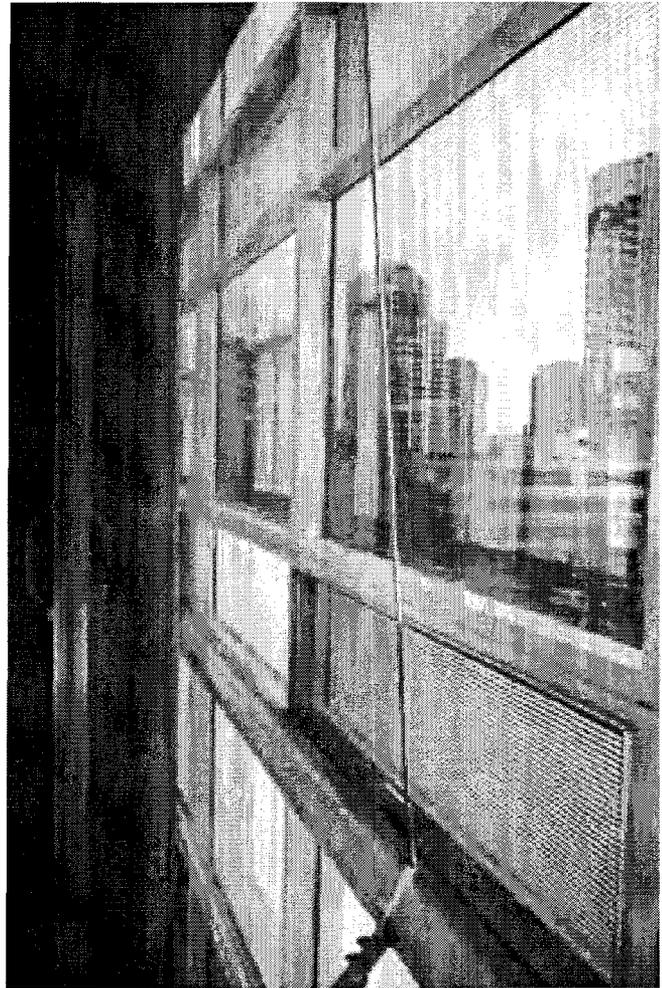
Fig. 14. View looking into the cavity. Note the differentiated glazing materials: clear and fritted, as well as the operable window.

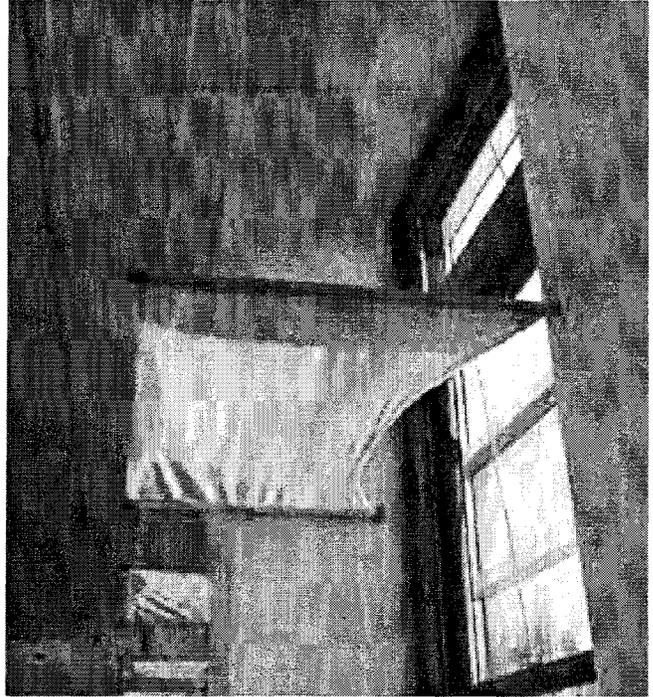
*Fig. 15. A view of the shading device attached to the interior of the windows. It also serves as a daylight reflector/light shelf to bounce light up to the white painted concrete ceilings.*

The envelope helps to modulate internal temperatures. Motorized windows on the new curtain wall, as well as operable existing units, enable the occupant to obtain natural ventilation when possible. The window glass on the curtain wall is fritted at different densities for temperature modulation. Photovoltaic panels are fitted in the new curtain wall and are linked to ventilation fans and dampers on the roof that ventilate the interstitial space. Each workstation is equipped with individually controlled diffusers to allow the flow of fresh air through a forced air plenum under the raised floor. The daylight reflectors allow light to penetrate deep into the building.

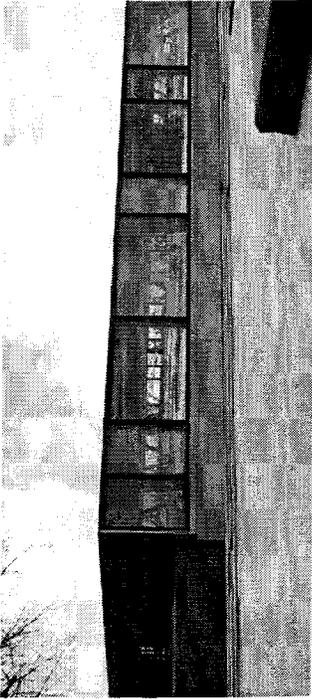
*Fig. 16. A view of the side elevation of the attached double skin component. You can clearly see through the entire space and it is evident that the space is not compartmentalized. The structure that holds the curtain wall away from the existing concrete frame forms a lacelike network within the cavity.*
