REAL STORIES FROM REAL BUILDINGS

Rainwater Harvesting

Joshua Cohen and Angela Matt

University of Oregon

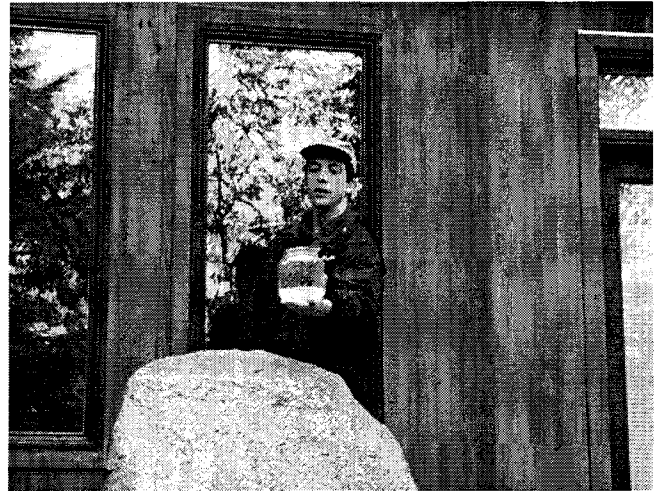
On a rainy day in April, we arrived at the Van Asperdt - Boesjes residence with a variety of glass jars and plastic tubs. Three locations in the catchment system were selected for sampling (see Fig. 3 & 4). Rainwater spilling from the *metal roof (1)* was the easiest to obtain. Wading through the partially filled cistern was necessary to obtain the other two samples. One was taken from the *plumbing (2)* system flowing into the cistern, a second from the standing water in the *cistern (3)*. Two other samples were collected for comparison. One was taken from the *tap water (4)* stream in the kitchen. The other was collected from the downspout of a different house with a more conventional asphalt *shingle roof (5)*.

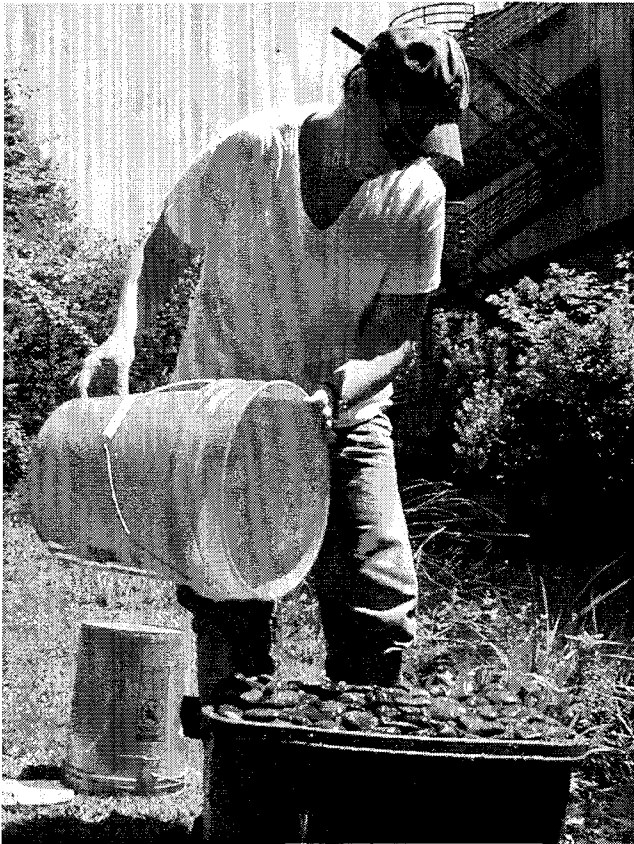
Fig. 7.

After assembling the filter components, it was necessary to flush the filter (Fig. 7) to remove impurities and encourage development of the *schmutzdecke*, a layer of biological slime that aids in trapping small particles. It is important to use unchlorinated water for the flushing, so the filter was set up on the banks of the Millrace, a side channel of the Willamette River. After approximately two hours of flushing, the effluent clarity was indistinguishable from incoming river water being poured into the filter.
